Nikon Coolscan 5ED (LS-50) with Scanhancer in SA-21

by Christopher Aisenbrey

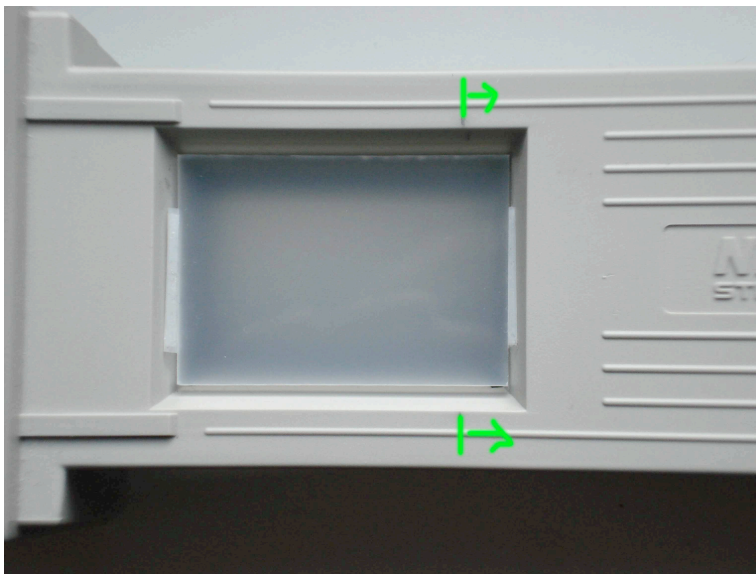
After switching on or changing a filmholder Nikon Coolscan performs some calibration steps. The calibration fails when Scanhancer covers the rear section of the window (marked by the green arrows in the figure). This blocks the scanner.

Figure: SA-21 filmholder equipped with Scanhancer plate (32mm x 46mm, special size for MA-21).

1. Switch on scanner in presence of a filmholder (e.g. MA-21), but in absence of Scanhancer.
2. Start Vuescan. (Close the tip window if present!)
3. Replace the filmholder with the SA-21 filmholder with fully covered window.
4. Vuescan will work!
